The Formation of Insoluble Stains on Glass and Glaze Surfaces

Thomas Kronberg and Kaj Fröberg

Åbo Akademi University, Process Chemistry Group, Combustion and Materials Chemistry, Biskopsgatan 8, 20500 Turku/Åbo, Finland

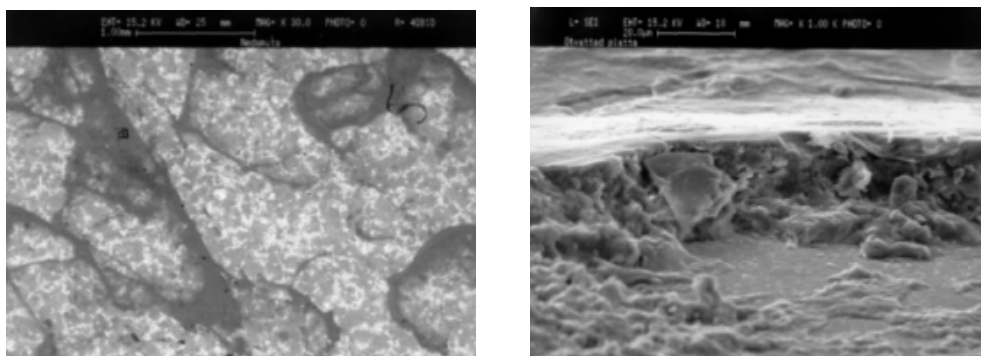
Analysis of the returned claimed glaze surfaces were first performed. The surfaces were cleaned and the insoluble parts were analyzed by SEM. The hard, drop-like stains on the surfaces were visible already by naked eye (Figure 1). Further analysis by EDX showed that the stains mainly consisted of Si. An analysis of the thick layer on uncleaned samples showed besides Si also Ca, Cu, S, and Cl (Figure 2). These impurities originated both from the daily usage of the bowl and the water used. The same result was found for several different samples.

Figure 2. SEM micrograph of the thick coating on an uncleaned surface.

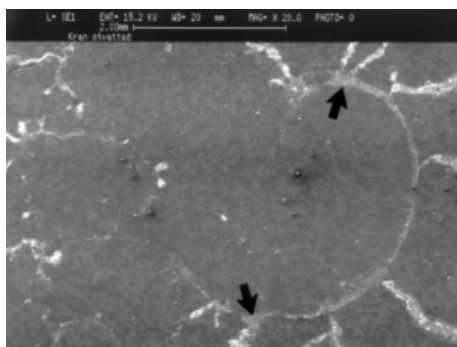
In the test series all glazes showed a similar formation of an insoluble silica gel on the surface when exposed to several tap waters (Figures 3 and 4). The stain formation could be noticed already after 250 dippings. However, if the samples were cleaned immediately with a cloth after every dipping, no stain formation could be noticed. The topography of the surfaces was studied by AFM (Figures 5 and 6). The average thickness of the deposits was $0.620\text{ }\mu\text{m}$ but even thicknesses more than $1\text{ }\mu\text{m}$ could be found. The average roughness ($0.045\text{ }\mu\text{m}$) of untreated surfaces indicates that there are good opportunities for the particles to attach to the surface thus initiating the stain formation. All these results indicate that neither the glaze composition nor the firing schedule had a major influence the stain formation.

Figure 3. SEM micrograph showing stain formation on glaze surface.

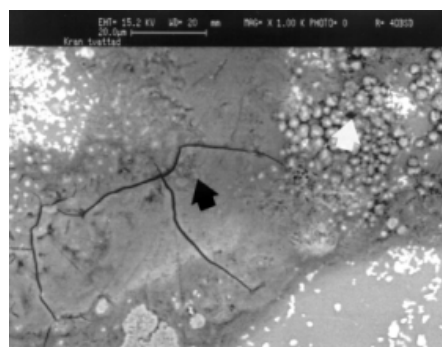
Figure 4. SEM micrograph showing Si-rich (black arrow) and Ca-rich (white arrow) regions.

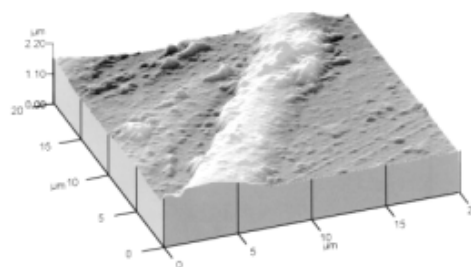
Figure 6. AFM image showing the topography of a glaze surface showing stain formation.

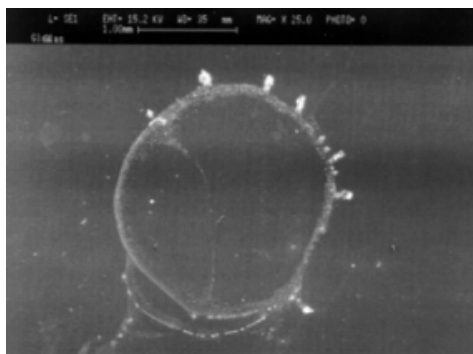
Similar experiments with the reference materials aluminium, stainless steel, acid resistant floor tile and glass were performed. Similar deposits to those on glazed surfaces were found also on all glass surfaces dipped in tap water. After cleaning, an insoluble Si-rich stain remained on the surface. The stain was even easier to notice on a transparent glass sample than on the other materials. The SEM and AFM images confirmed that the deposits laid on the surface and had not penetrated through the surface (Figures 7 – 10). The formation of a silica gel on the surface could also be observed for the other reference materials dipped in the tap waters. Similar Si-rich stains could also be found on the stainless steel and aluminium samples containing no Si in the material itself (Figure 11 and 12). This indicates that the origin of the stains can be traced back to deposition of impurities in the tap water rather than on dissolution and resorption of corrosion products of glaze or glass components on the surfaces. Besides the silica gel rich stains, usually also stains containing calcium, sulphur and chloride could be found on the surfaces, but by careful acidic washing these components could be removed from the stains leaving only the insoluble silica gel on the surface.

Figure 7. SEM micrograph showing stain formation on glass surface.

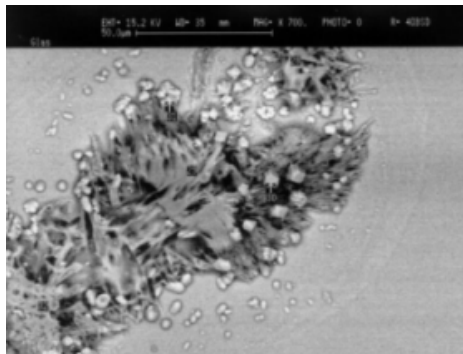
Figure 8. SEM micrograph of Si- and Ca-rich deposits on glass surface.

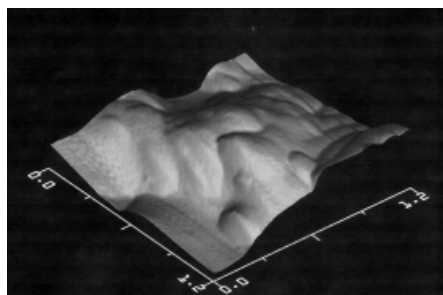
Figure 10. AFM image of stain formation on glass surface.

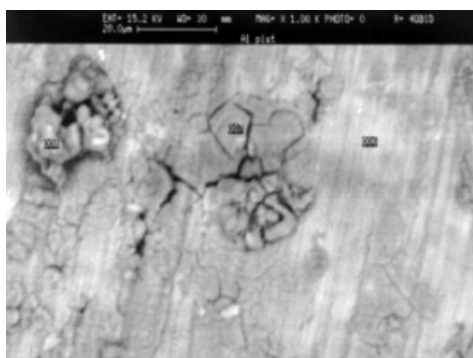
Figure 11. SEM micrograph of Si-rich deposits on aluminium substrate.

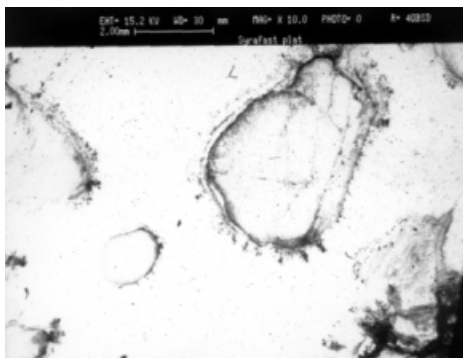
Figure 12. SEM micrograph of Si-rich deposits on stainless steel surface.
